HELICOPTER SECONDARY STRUCTURES
RELIABILITY AND MAINTAINABILITY
INVESTIGATION

Kenneth B. Krieger

United Aircraft Corporation

July 1974

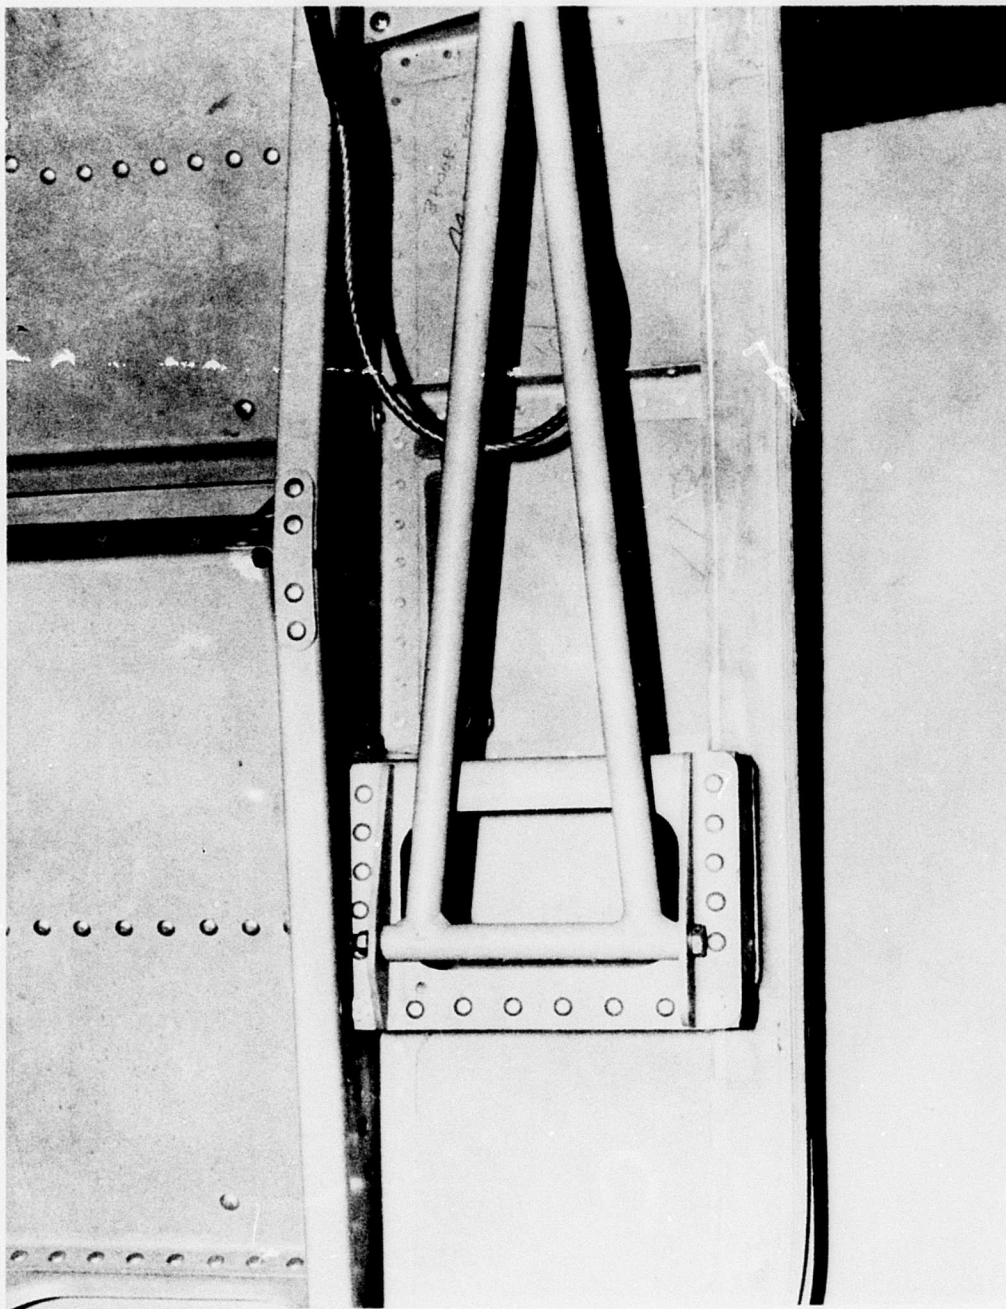
Figure 35. Lower Personnel Door, Redesign, Support Assembly.

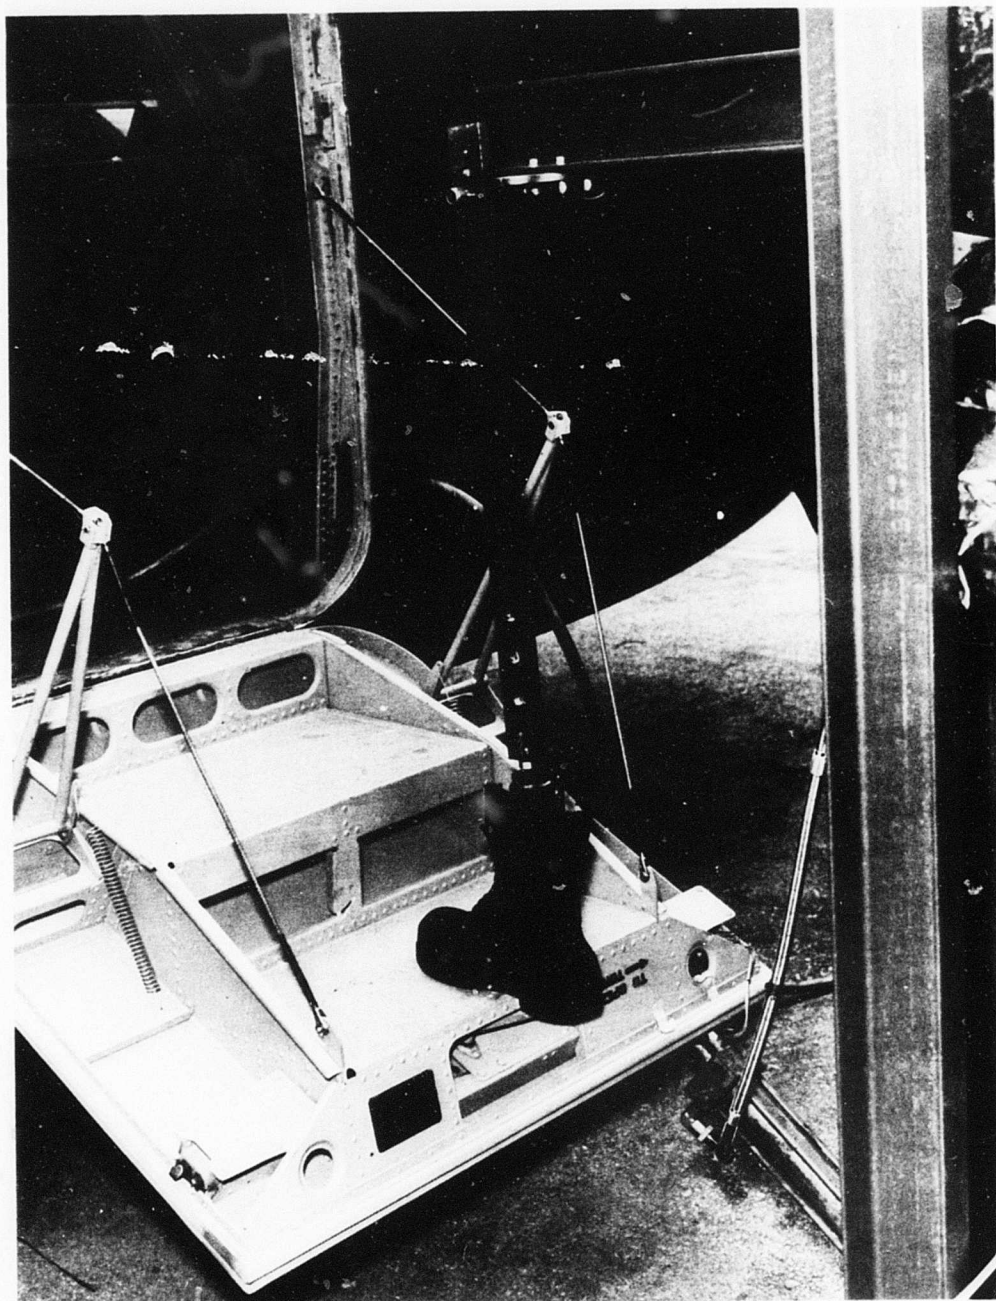
Figure 36. Lower Personnel Door, Riser Kick Test.

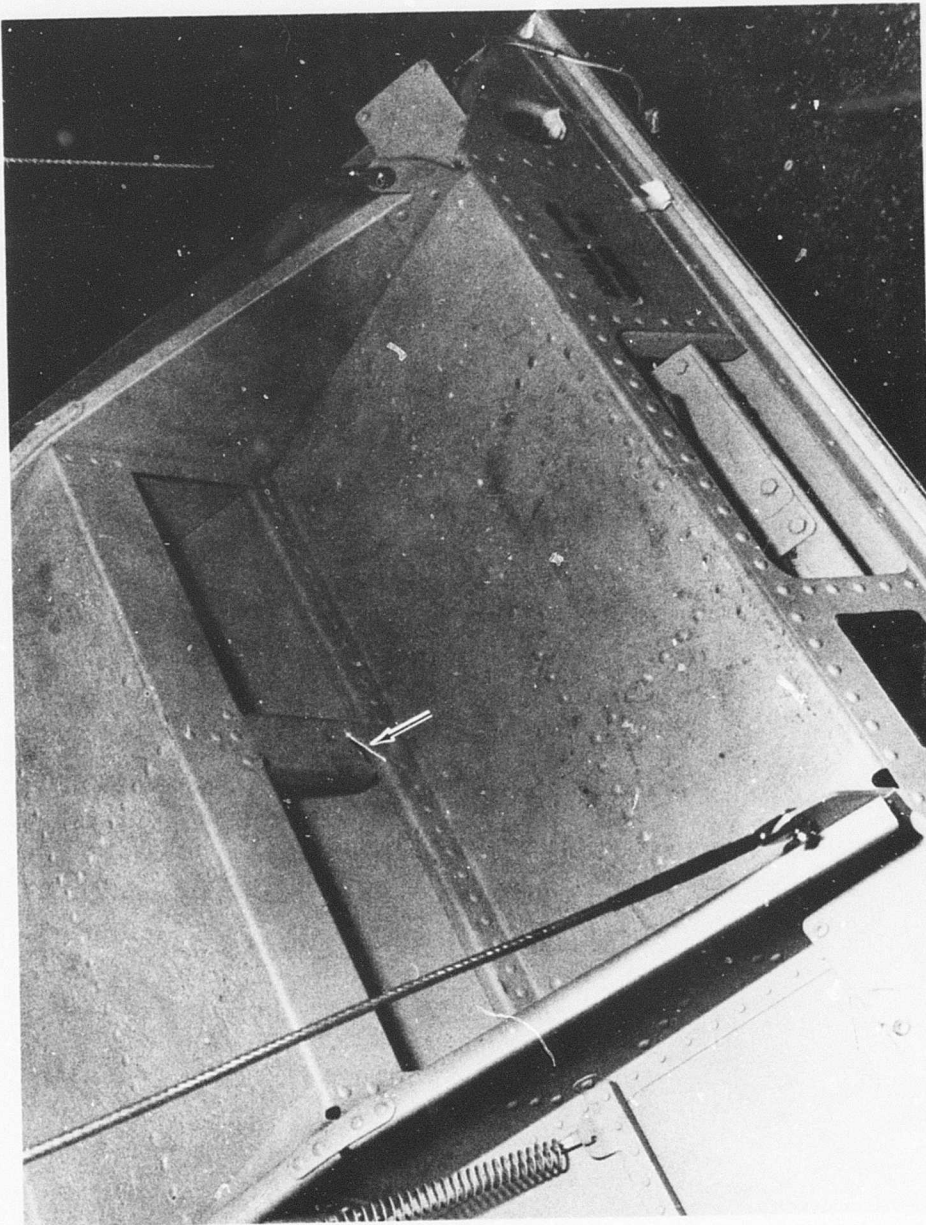
Figure 37. Lower Personnel Door, Original, Riser Fracture.

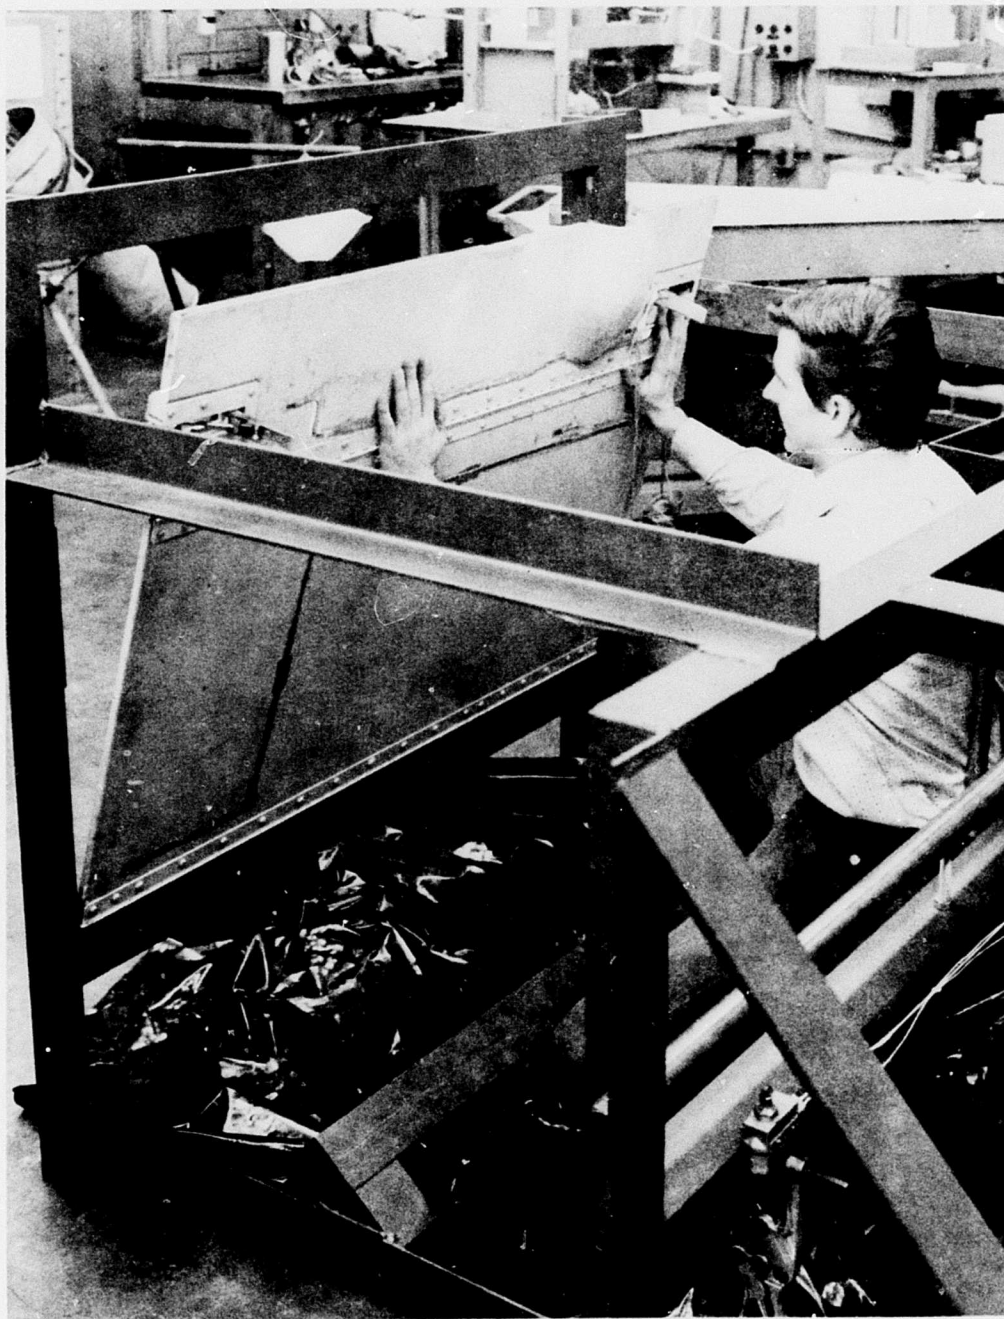
Figure 41. Work Platform Assembly, Manual Cycling.

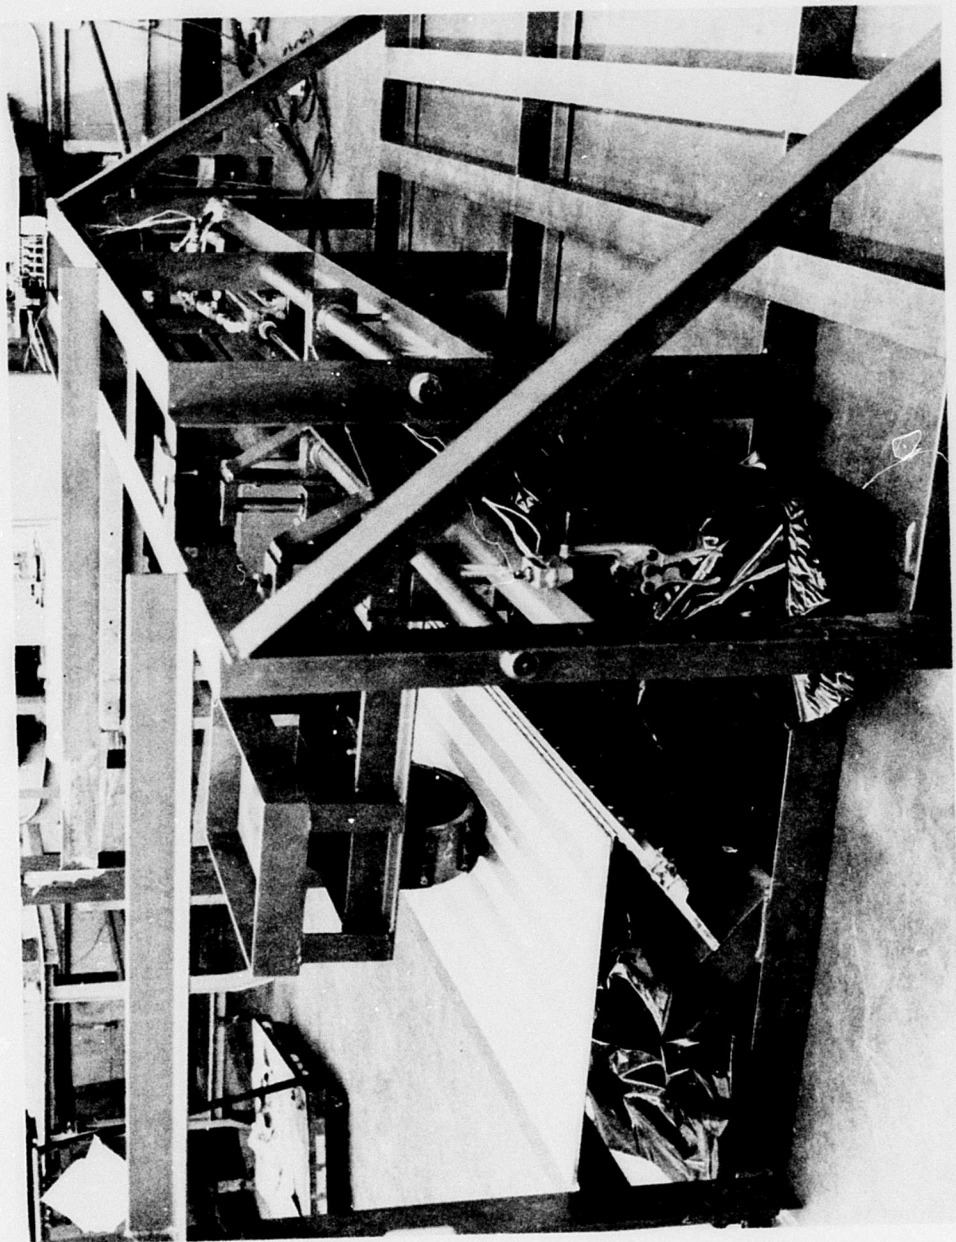
The roller load (Figure 42) simulating men working on the platform was expected to produce the delamination field mode on the original design work platform assembly. However, this did not occur. Both the original and redesigned work platform assemblies lasted the full test without exhibiting the primary field mode of failure. The original did develop a field mode crack above the aft latch (Figure 43) after 300 hours of test when the roller load was increased to 400 pounds (2 men) from the 200-pound (1 man) loading. The crack after initial formation did not propagate further. This type of crack did not appear on the redesigned work platform assembly.

Figure 42. Work Platform Assembly, Roller Load.

The redesigned work platform assembly is expected to eliminate the delamination problem, as it is constructed of an aluminum and honeycomb structure rather than an aluminum and fiber glass laminate on a balsa wood core.

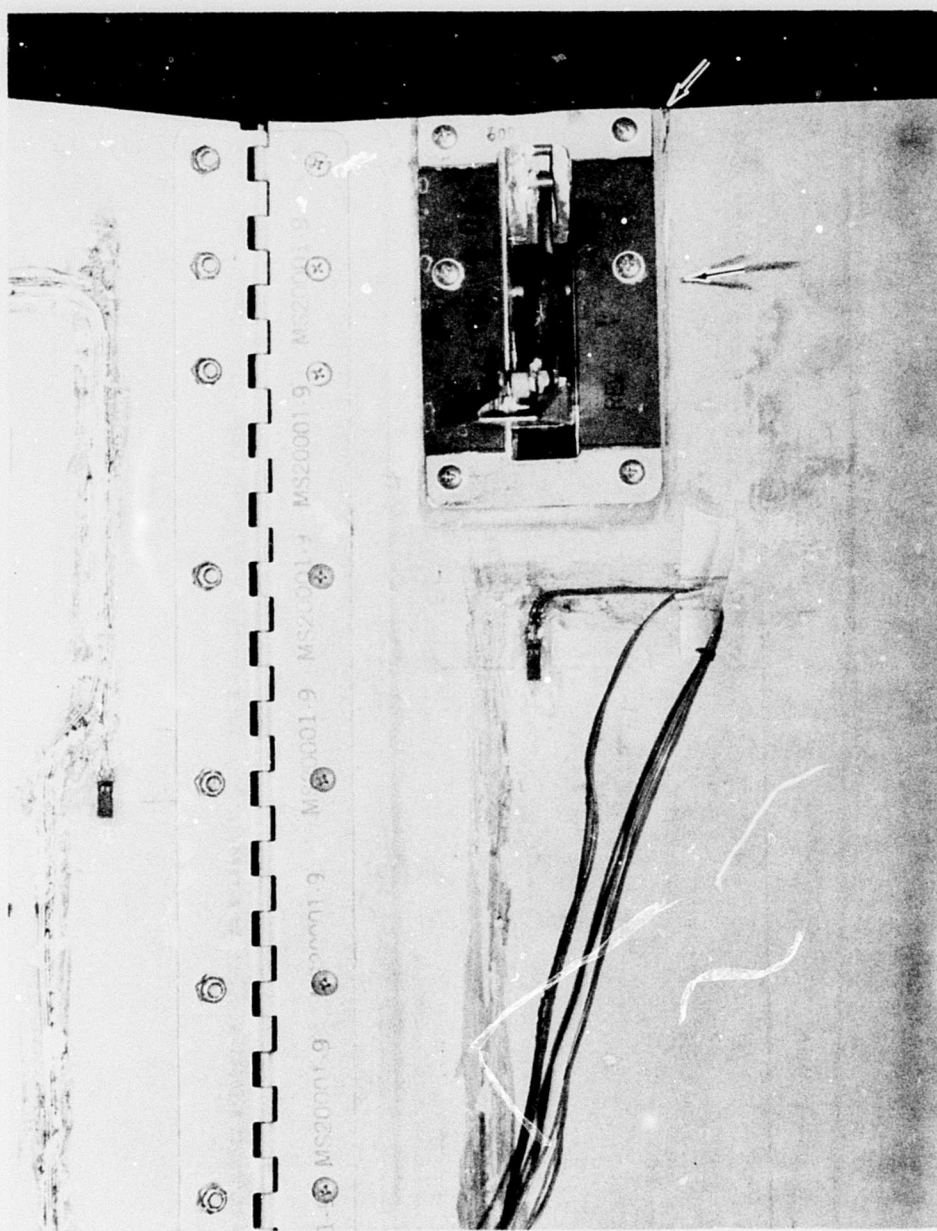
Figure 43. Work Platform Assembly, Original, Crack.

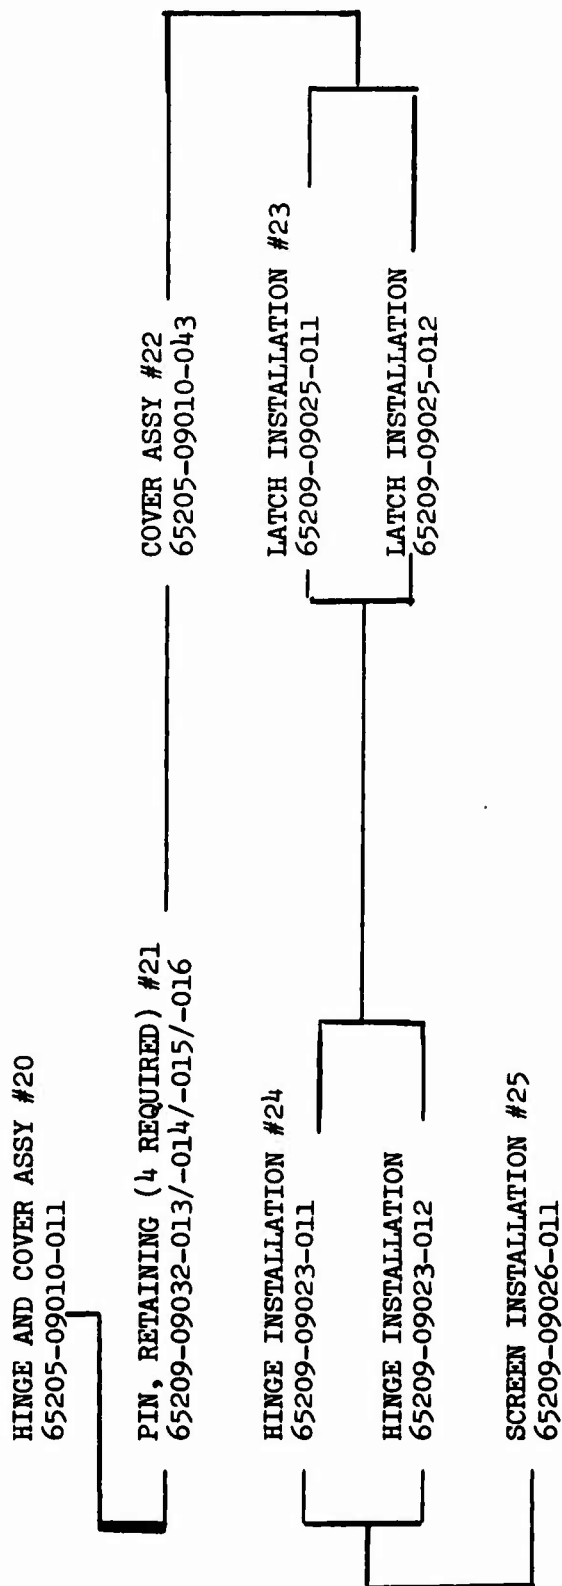
Diagram No. 2

TABLE XXIV. RELIABILITY LOGIC DIAGRAM - HINGE AND COVER ASSEMBLY

ALUMINUM STIFFENERS EVERY 7½ INCHES

Probable Areas of Failure

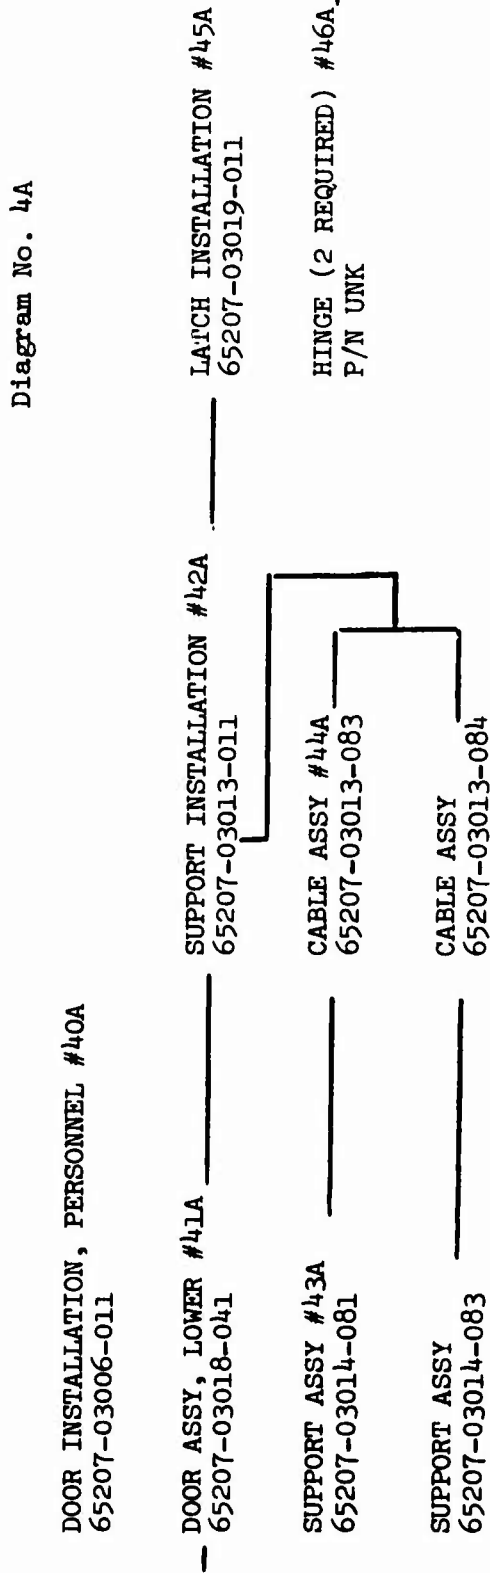
TABLE XXXIII. RELIABILITY LOGIC DIAGRAM - PERSONNEL DOOR

DUAL PIN LATCH
REDUNDANT SUPPORT ASSY

Probable Areas of Failure

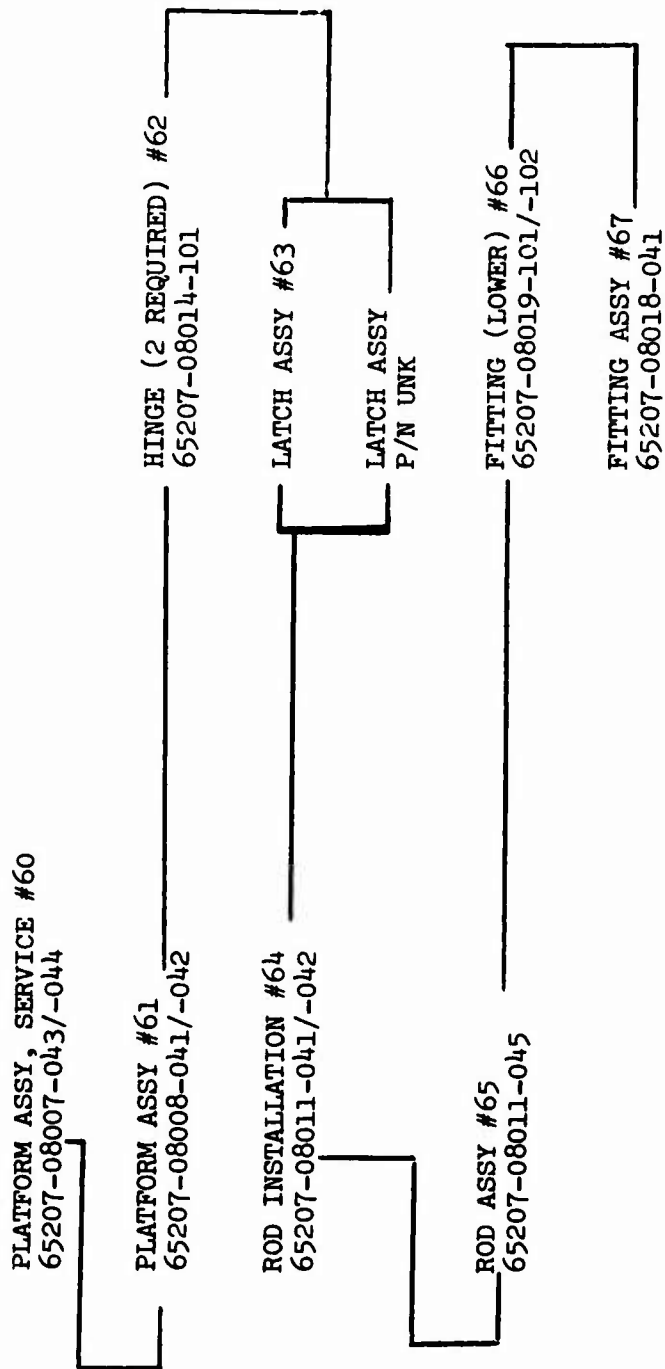
Diagram No. 6

TABLE XXXIX. RELIABILITY LOGIC DIAGRAM - SERVICE PLATFORM

PLATFORM IS HINGED IN "FAIL SAFE" DIRECTION
REDUNDANT LATCHES. HINGE SPRING LOADED CLOSED

Probable Areas of Failure

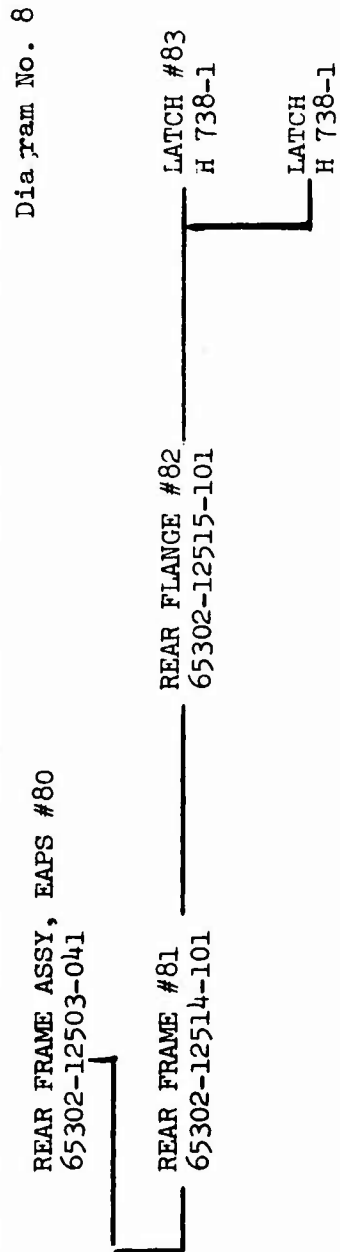
TABLE XLV. RELIABILITY LOGIC DIAGRAM - EAPS REAR FRAME

Probable Areas for Failure

1. Cracking at Rivet Holes
2. Breaking of Flange During Maintenance and Inspection
